Manhole Inspection Summary

Manhole # S25M__032MH

Insp Date: **3/6/08 5:39 PM**

Location Address: **1009 Glyndon**

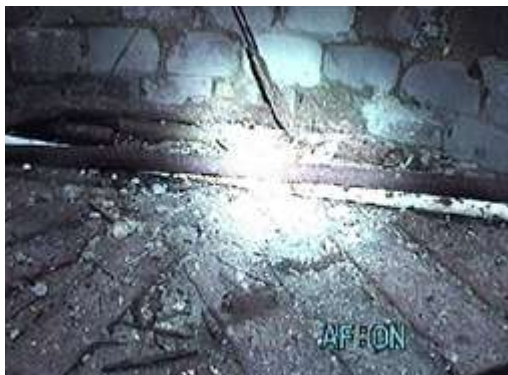
Misc.

debris on bench

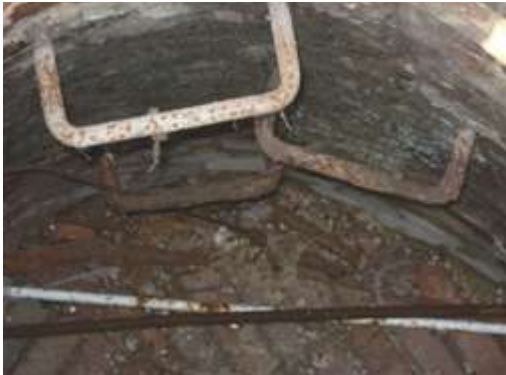
Defect 1

Infiltration: ☐ None ☐ Joint ☐ Cracks ☐ Mortar ☐ Roots ☒ **Wall**

infiltration in corbel and chimney-frame
connect

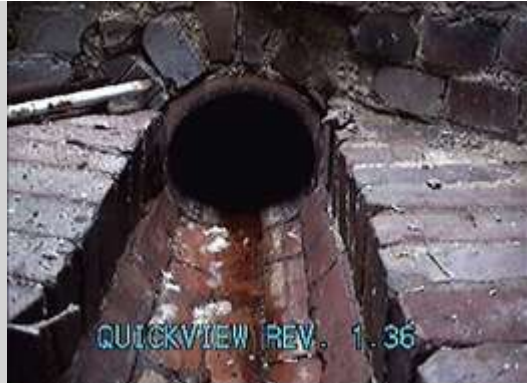
12 O'Clock Outflow

Pipe Height: **8.4** (in.) Rod and Bar (Angled)
Pipe Material: **Clay** ☐ Pipe Lined
Invert Depth: **6.70** (ft.) Flow Characteristics: **Slow**
Deposits: ☒ None ☐ Mud ☐ Sludge ☐ **Debris** ☐ Grease
Silt Depth: **0** (in.) Deposits Extent:
Infiltration: **Evidence** Pipe Seal Cond: **Unknown**

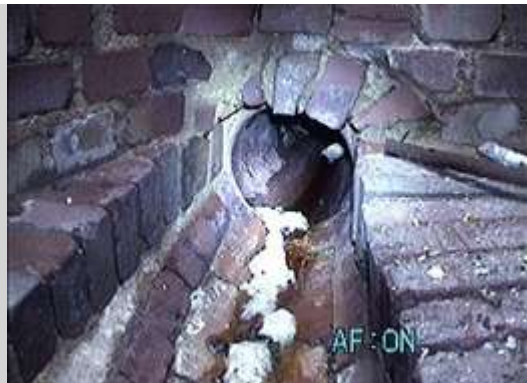
7 O'Clock Inflow

Pipe Height: **8.4** (in.) Rod and Bar (Angled)
Pipe Material: **Clay** ☐ Pipe Lined
Invert Depth: **6.80** (ft.) Flow Characteristics: **Slow**
Deposits: ☐ None ☐ Mud ☐ Sludge ☒ **Debris** ☐ Grease
Silt Depth: **1** (in.) Deposits Extent: **Light**
Infiltration: **Evidence** Pipe Seal Cond: **Unknown**
